Compressor Train Retrofit Improves System Reliability and Output

GASPAC Dry-Running Gas Seals Key to Successful Solution

Bulletin FSG-SS-015 (E) Printed in USA. December 2010.
© Flowserve Corporation

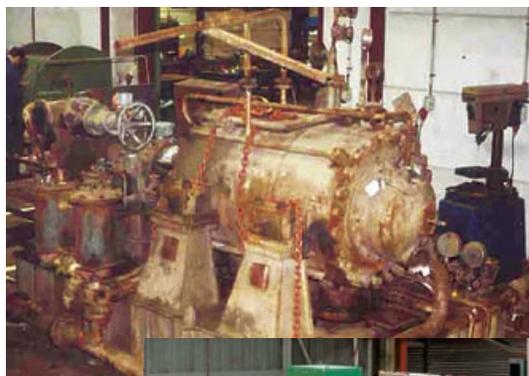
In 1997, the Nerefco Rotterdam Refinery was experiencing severe reliability issues with the steam-driven, sevenstage BCL Nuovo Pignone compressor providing recycle gas service in its CDU. Bad rotor-dynamic behavior, including oil whip and excessive vibration due to seal-oil build-up on the impellers, had resulted in several failures. Furthermore, inadequate steam supply and poor steam quality were limiting the output of the compressor.

Before

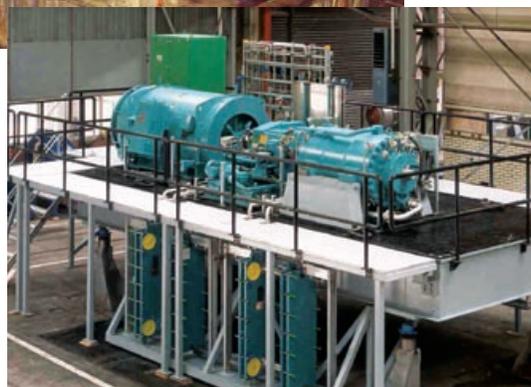
After (Packaging at Flowserve facility)

Compressor capacity issues were addressed by replacing the steam turbine with a 1400 kW (1877 hp) electric motor and a fluid coupling/step-up gear. This enhancement allowed a stepless speed regulation from 4000 rpm to 12 970 rpm. The new drive configuration, however, resulted in a footprint too large for the existing concrete foundation table. Compounding the problem, the project timetable precluded extensive new civil construction.

Flowserve introduced a new foundation concept for refineries, a "low-tuned" honeycomb steel skid with spring supports that virtually eliminated sensitivity to operating excitation forces. (Sensitivity to nozzle load forces and foundation resonance were also minimized.) The entire compressor train, with all instrumentation, control and auxiliary systems, was constructed and tested in a Flowserve Service Center and then transported to the refinery CDU. With the new non-grouted foundation/baseplate, installation and commissioning was accomplished in just 2.5 weeks.
